Ceiling/Floor Partition Separation Update

By: David B. Brakeman, P.E., S.E.

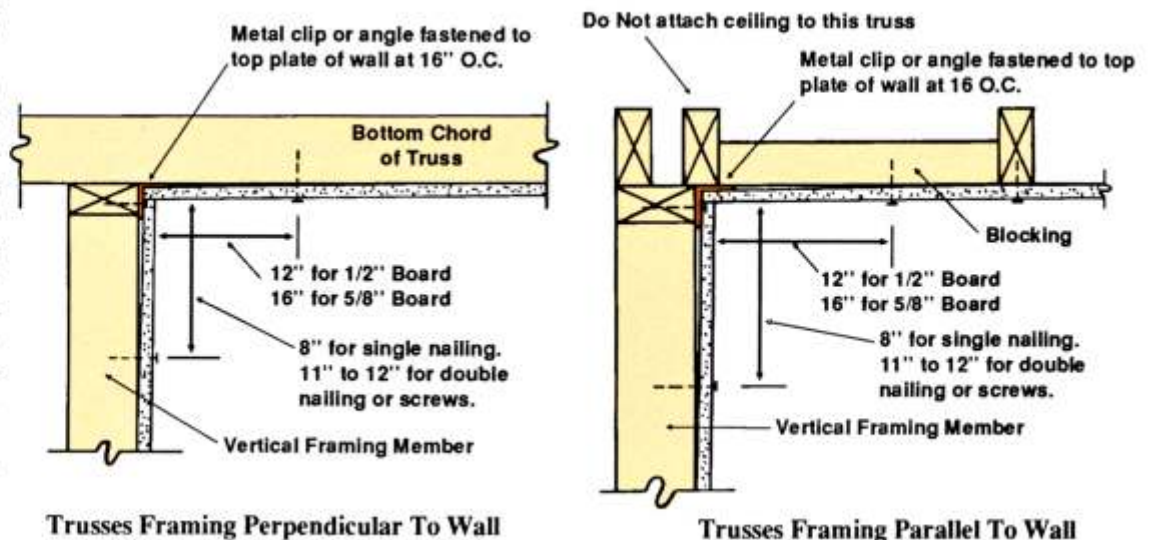
Floating Interior Angles

To minimize the possibility of fastener popping in areas adjacent to the wall and ceiling intersection, the floating angle method of application may be used for either single or double layer application of gypsum board to wood framing. This method is applicable where single nailing, double nailing or screw attachment is used. Gypsum board should be applied to ceilings first. (See Figures) Floating interior angles should be used where fire ratings are required.

The first attachment into each ceiling framing member framed perpendicular to the intersection should be located 12 inches out from the wall intersection for 1/2" board and 16 inches for 5/8" board.

Gypsum board on sidewalls should be applied so as to provide a firm support for the floated edges of the ceiling gypsum board. The top attachment into each stud should be located 8 inches down from the ceiling intersection for single nailing and 11 to 12 inches for double nailing or screw application. (See Figures) Also, see Gypsum Association GA 216-85. ▲
