# SY42 FIELD STUBBING REPAIR DETAIL

REF	STUB SY42
DATE	10/01/14
DRWG	REPSY42A1014

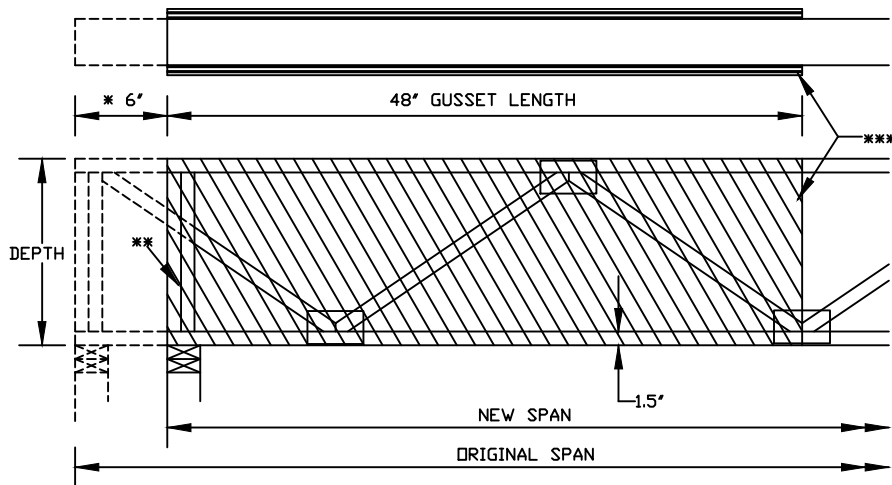
\* THIS REPAIR ALLOWS FOR A SINGLE SPAN, TWO BEARING, NON-CANTILEVERED, SY42 TRUSS TO BE SHORTENED A MAXIMUM OF 6" FROM ONE OR BOTH ENDS. TRUSSES SHALL SUPPORT A MAXIMUM TRIBUTARY LOAD AREA OF 2'-0" WITH NO OTHER UNIFORM OR CONCENTRATED LOADS.

\*\* (2) 4x2 #3 FIELD-APPLIED BLOCKS. SCRIBE TO CUT FOR TIGHT FIT. ATTACH TO TRUSS WHERE SHOWN.

\*\*\* REPAIR TRUSS USING 1/2" APA RATED 32/16 OR 3/4" APA RATED 48/24 SHEATHING (REFER TO CHART) NAILED TO BOTH FACES OF TRUSS. SIZE GUSSETS AS SHOWN. USE 8d BOX (0.113" DIA. x 2.5") NAILS IN 1 ROW AT 2" O.C. NAIL INTO ALL MEMBERS IN CONTACT WITH GUSSETS.

A CHASE OPENING, IF PRESENT, MUST BE LOCATED AT CENTERLINE OF TRUSS SPAN. TRUSS MAY BE CUT BACK UP TO 6" AT EACH END, UNLESS OTHERWISE SPECIFIED ON ENGINEER'S SEALED DESIGN.
