Metal Plate Connected Wood Truss Inspection

Part 1

Part 2

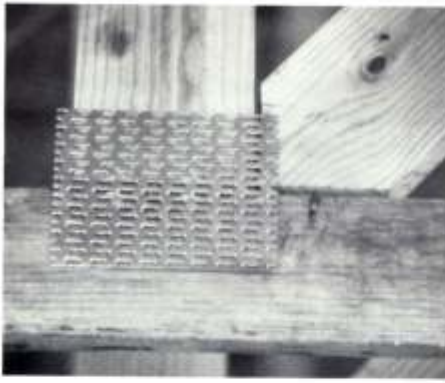
Figure 1

Correctly sized plates may be inadequate due to plate misplacement (*Figure 1*) or changes in the size of the connected member. For example, in a three-member web joint, if wider lumber was substituted for the center member, but the specified plate size was not increased, the two outside members may not have an adequate contact area. Knots and wane in the contact area of the connector plate may be acceptable as long as the provisions of QST-88 are met.

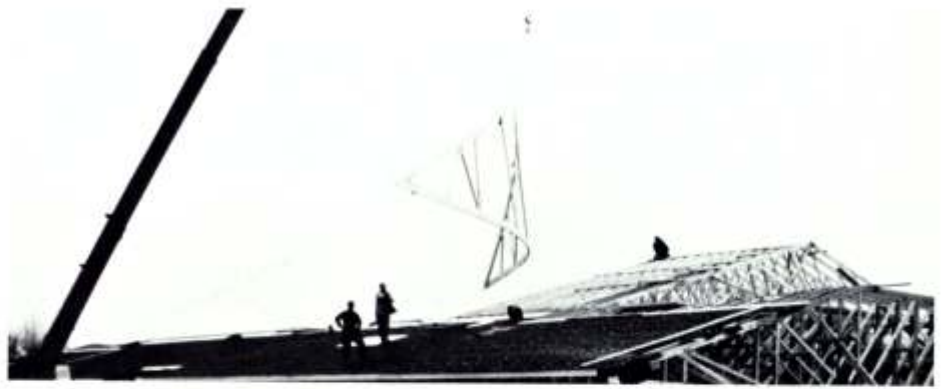
Figure 2

Lifting without spreader bars will cause extreme bowing, especially in long-span trusses, (Figure 2) which are very limber perpendicular to the intended loading direction. Connector plates on the convex side of the bow, particularly the splices toward the center of the truss, can pop out or may be stretched close to failure, whereas connectors on the concave of the bow may buckle. A small crease or bubble along the splice indicates that this condition has occurred.

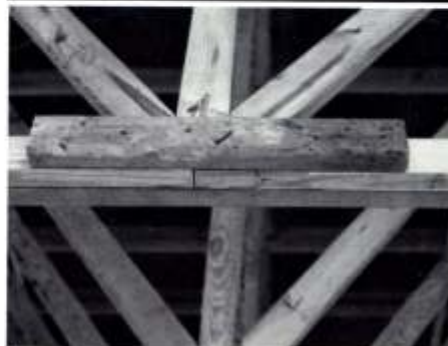
Figure 3

Also, truss members can be cracked by rough and improper handling. These cracks are not always found during installation, but they open up when the truss is loaded. Although broken members may appear to be repaired, a repair might only be a patch that is inadequate (Figure 3) to restore the full structural integrity of the damaged members. Therefore, repairs on trusses should always be backed up by engineering design, and proper execution of the repairs must be verified.

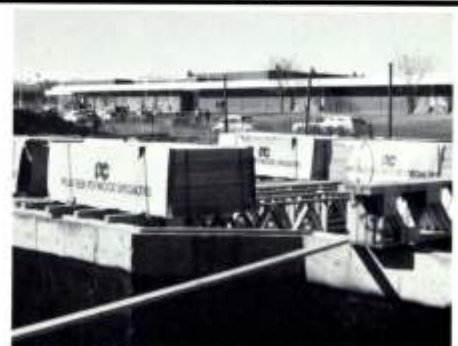
Figure 4

Most trusses are spaced 24 inches (610mm) on center. However, designs will sometimes specify a spacing less than 24 in. on center. This variation from the customary spacing can be missed during the erection process. Excessive localized deflection of a few adjoining trusses within a continuous run of otherwise identical trusses may be a sign of overloading by construction material that was stored temporarily on the trusses (Figure 4). These trusses must be checked carefully for potential damage.

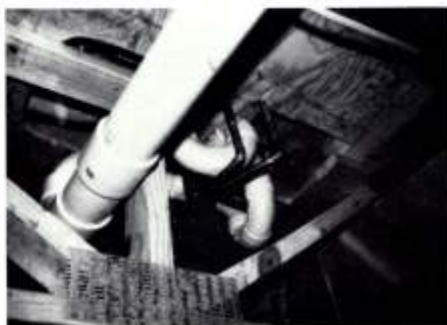
Figure 5

Frequently, field modifications are found around chimneys. Trusses in the way of the chimney may have been cut, transferring the load by headers to adjacent trusses. Sometimes the cut trusses are left supported on the chimney, which may be a code violation. Proper framing around fireplaces requires engineering design and always deserves special attention during truss inspection. Similar problems occur where skylights, attic fans, and attic access openings are added after construction has begun or during remodelling (Figure 5).

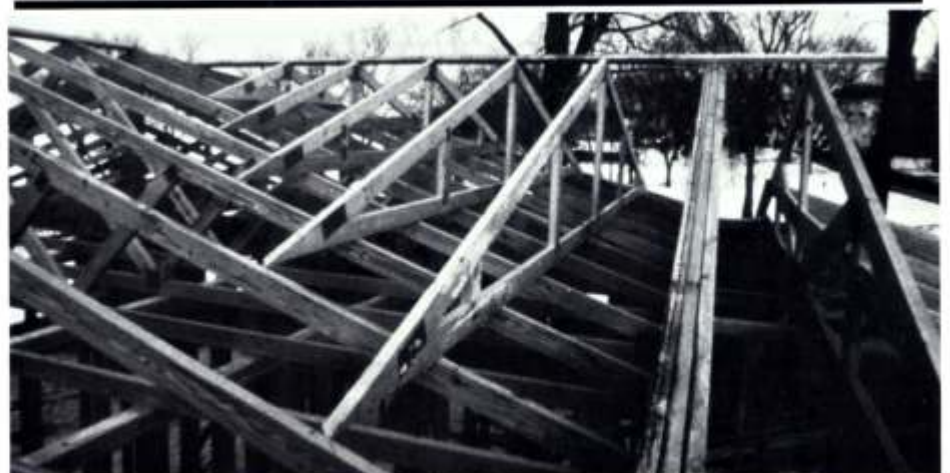
(Figure 1)

Special shapes and roof lines such as valleys and hips are often formed by applying conventional framing over the trusses. The conventional framing members support the roof load and transfer it as concentrated loads to the supporting trusses (*Figure 1*). This can cause critical loading conditions if the framing member is applied between panel points, unless the supporting truss was designed for these concentrated loads.

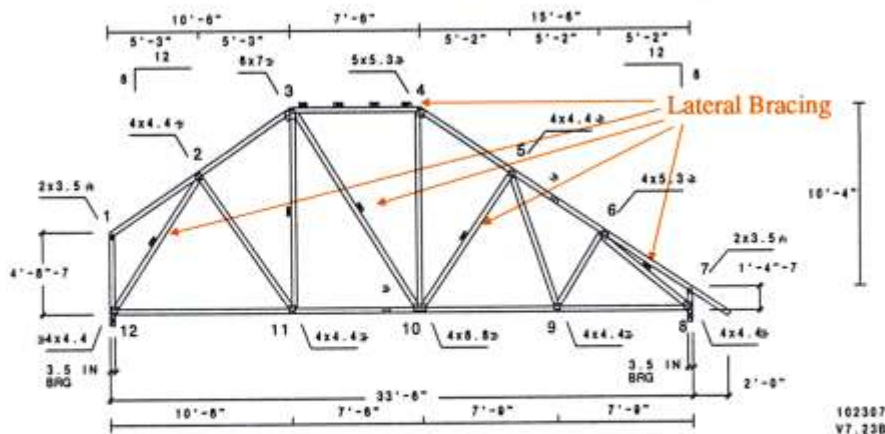
(Figure 2)

tions and the number of lateral braces are specified on the truss design drawings (Figure 2). Each end of a row of continuous lateral bracing must be connected to a fixed point to prevent the bracing from acting only as a tie that would force all braced members to buckle simultaneously. The fixed points can be provided by extending and connecting the bracing to the walls, the roof sheathing, or by connecting to cross bracing in the plane of the diagonal or vertical webs. The truss design drawing does not show where these fixed points are located or what type of connection must be provided; therefore, they often are not provided in the field. In some instances in which continuous lateral bracing cannot be installed, scab bracing or T-bracing is specified. These applications are typical when the web configuration changes from truss to truss. Since this bracing typically is field applied, and only a few odd members require this type of bracing, it can easily be missed in the field; thus, requiring special attention during the inspection.

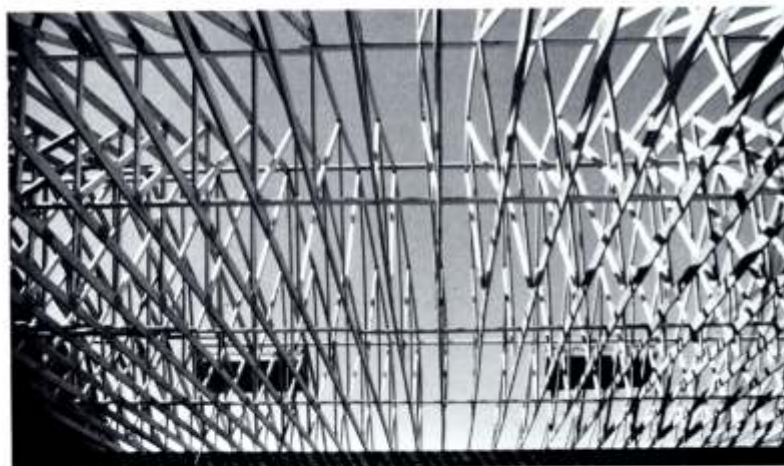
(Figure 3)

Trusses with purlins only on the top chord, such as the flat top chord of the carrier truss on piggy-backed trusses, require cross bracing to prevent simultaneous buckling of all top chords (Figure 3). This cross bracing should be installed at each end of the building and at regular intervals throughout the length of the building. It must be connected to shear walls or other suitable fixed points of the structure. Many buildings that were not erected under the supervision of a competent professional may lack these bracing systems.

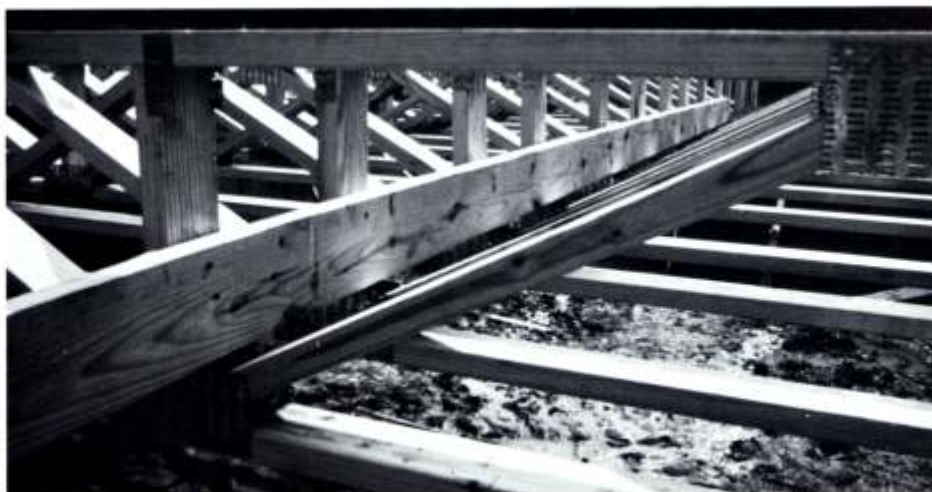
Floor trusses require strongbacks, which are typically continuous 2- x 6-in. (38- x 140-mm) members attached with three 16-penny nails to vertical webs (Figure 4) of the trusses (TPI, 1991a). The number of rows and the location should be specified on the truss design drawing. Some builders prefer to use rows of cross braces, which are
