SY42 FIELD STUBBING REPAIR DETAIL

TC LL	40 PSF	REF	STUB SY42
TC DL	10 PSF	DATE	10/01/14
BC DL	5 PSF	DRWG	REPSY42A1014
BC LL	0 PSF		
TOT. LD.	55 PSF		
DUR. FAC.	1.00		
SPACING	24.0"

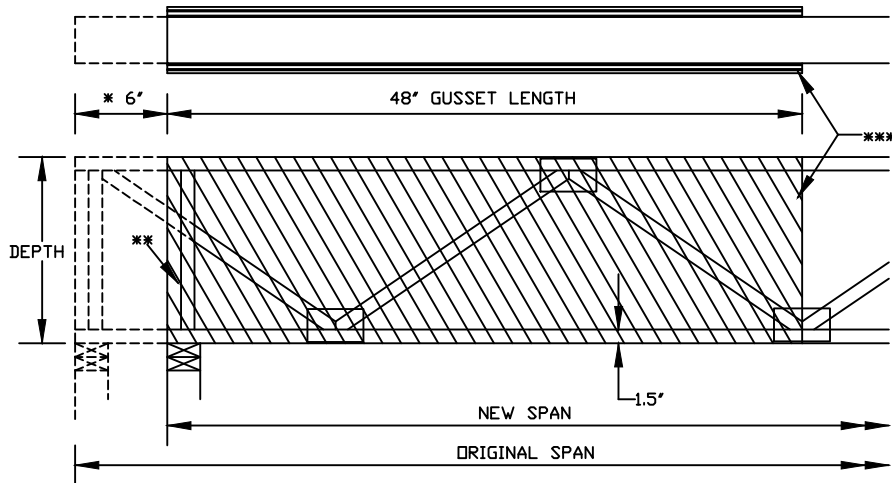
* THIS REPAIR ALLOWS FOR A SINGLE SPAN, TWO BEARING, NON-CANTILEVERED, SY42 TRUSS TO BE SHORTENED A MAXIMUM OF 6" FROM ONE OR BOTH ENDS. TRUSSES SHALL SUPPORT A MAXIMUM TRIBUTARY LOAD AREA OF 2'-0" WITH NO OTHER UNIFORM OR CONCENTRATED LOADS.

A CHASE OPENING, IF PRESENT, MUST BE LOCATED AT CENTERLINE OF TRUSS SPAN. TRUSS MAY BE CUT BACK UP TO 6" AT EACH END, UNLESS OTHERWISE SPECIFIED ON ENGINEER'S SEALED DESIGN.

** (2) 4x2 #3 FIELD-APPLIED BLOCKS. SCRIBE TO CUT FOR TIGHT FIT. ATTACH TO TRUSS WHERE SHOWN.

*** REPAIR TRUSS USING 1/2" APA RATED 32/16 OR 3/4" APA RATED 48/24 SHEATHING (REFER TO CHART) NAILED TO BOTH FACES OF TRUSS. SIZE GUSSETS AS SHOWN. USE 8d BOX (0.113" DIA. x 2.5") NAILS IN 1 ROW AT 2" O.C. NAIL INTO ALL MEMBERS IN CONTACT WITH GUSSETS.

1/2" 32/16 RATED SHEATHING	
MAXIMUM NEW SPAN	MINIMUM DEPTH
35-01-00	20"
31-07-00	18"
28-00-00	16"
24-04-00	14"
20-08-00	12"
16-11-00	10"

3/4" 48/24 RATED SHEATHING	
MAXIMUM NEW SPAN	MINIMUM DEPTH
40-03-08	20"
36-03-08	18"
32-03-08	16"
28-03-08	14"
24-03-08	12"
20-03-08	10"
