Repair Detail to Remove End Vertical (Ribbon Notch Vertical)

REF STUB SY42
 DATE 11/18/2020
 DRWG REPSY42EV1120

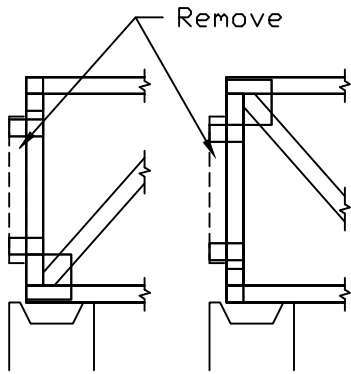
Condition 1 - Ribbon notches at top and bottom, diagonal web at top or bottom joint.

- Maximum Bearing Reaction of 2000#.
- No Repair is needed for this condition provided that all the criteria stated above are met.
