BREAK JOINT PLATE LOCATION DETAILS

BREAK JOINT

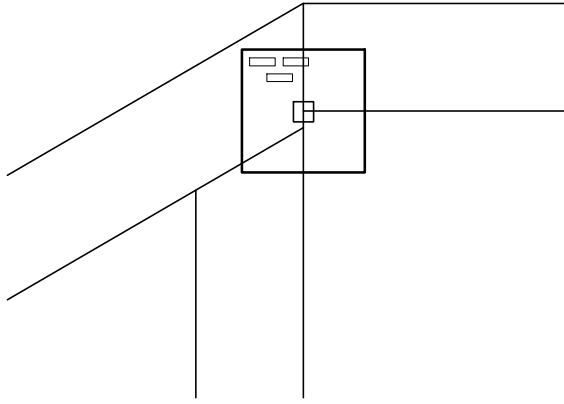
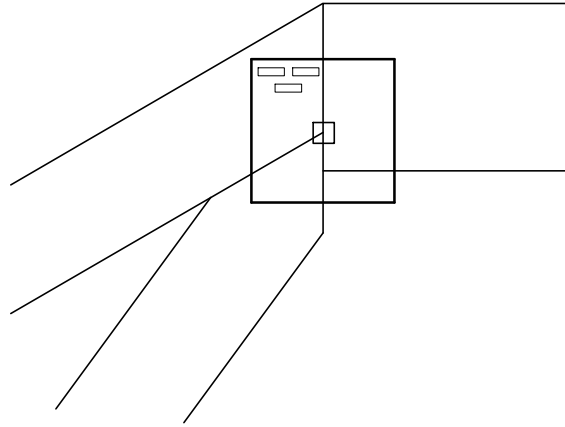
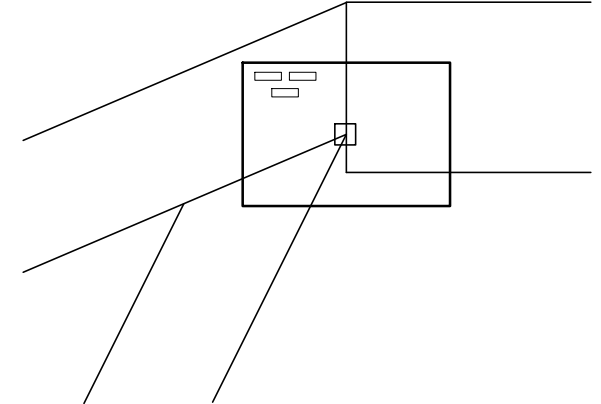
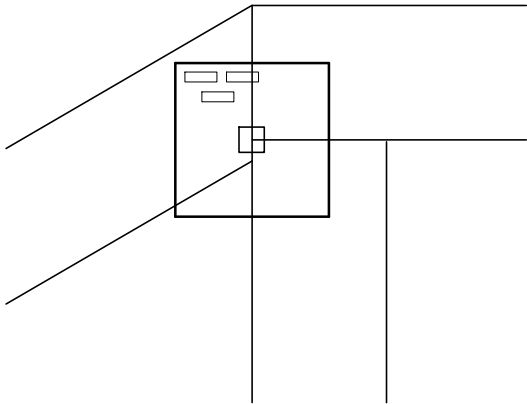
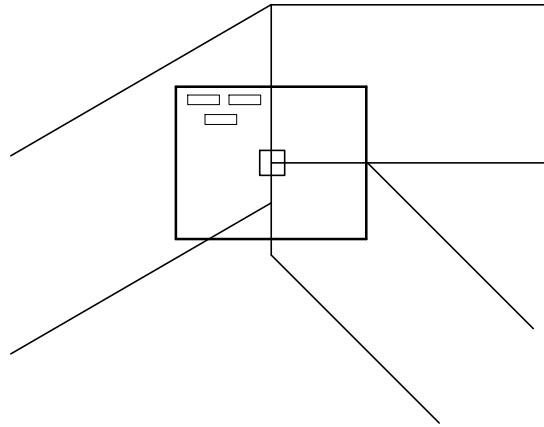
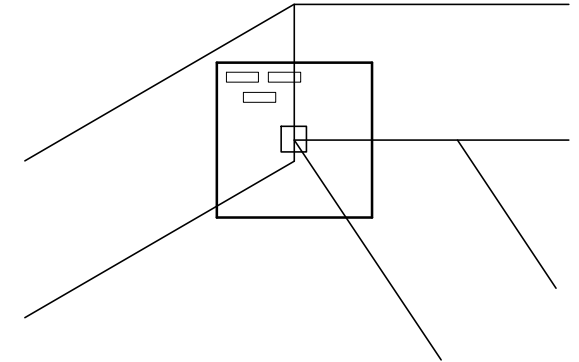
NOTES:
THE PLATE IS CENTERED ON THE CHORD BREAK AT THE BOTTOM EDGE OF THE OUTERMOST TOP CHORD OR THE TOP EDGE OF THE OUTERMOST BOTTOM CHORD. THE PLATE WILL BE SHIFTED PERPENDICULAR TO THE CHORD UPON WHICH THE PLATE IS ALIGNED.
□ LOCATES PLATE CENTER.
