BREAK JOINT PLATE LOCATION DETAILS

BREAK JOINT

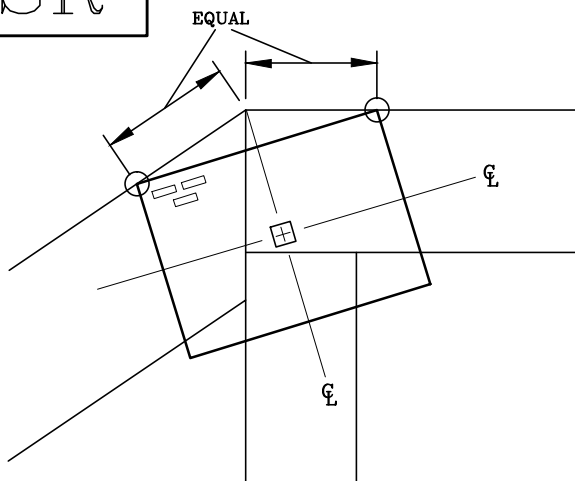
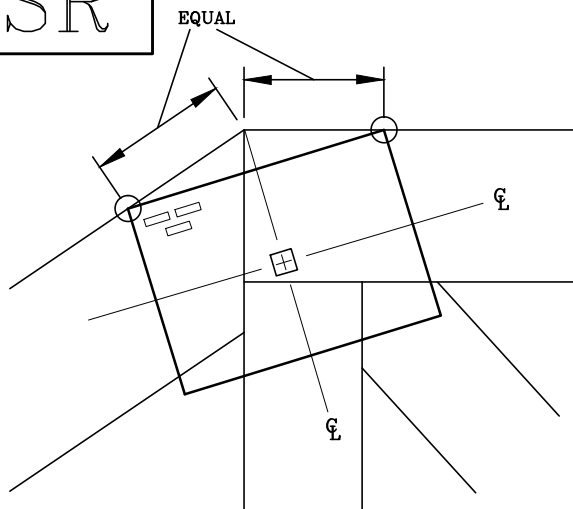
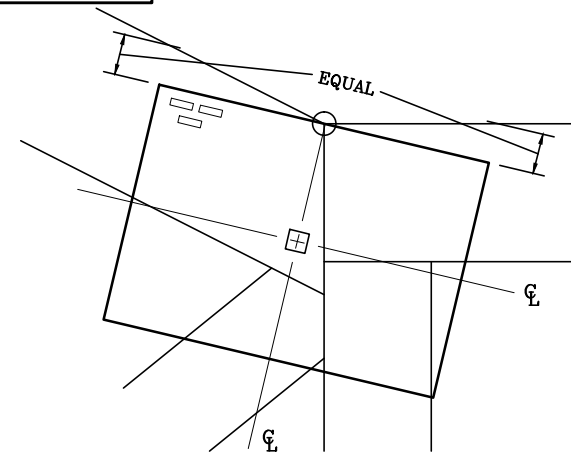
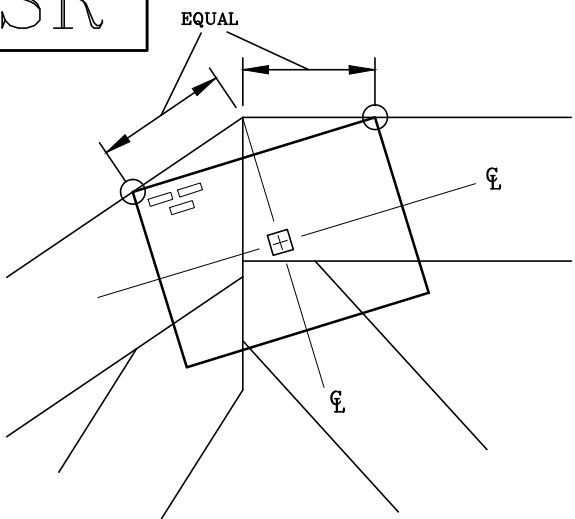
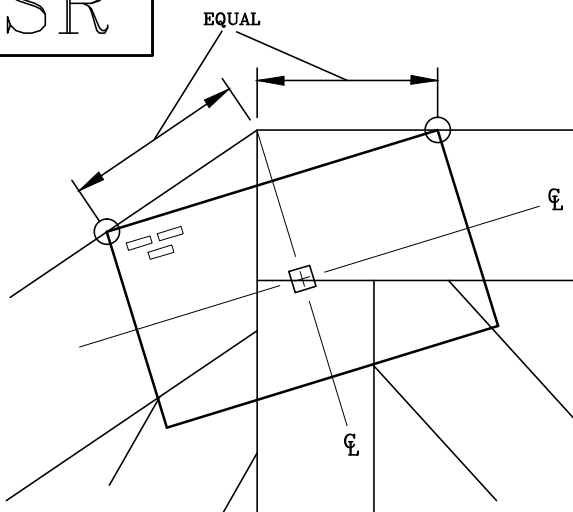
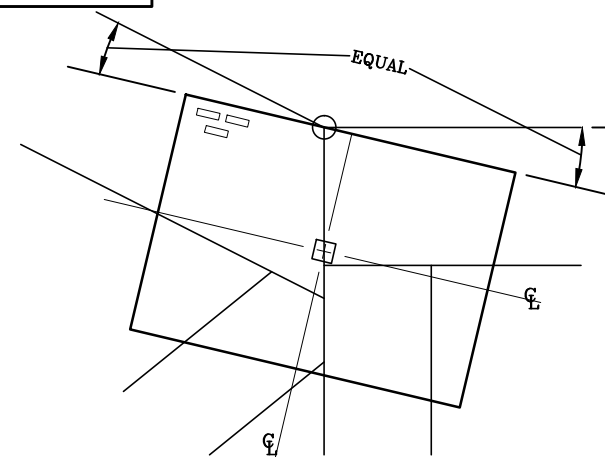
- NOTES:
 PLATE IS ALIGNED ALONG THE BISECTOR OF THE PITCH BREAK ANGLE.
 ○ LOCATES PLATE CORNER OR FLUSH EDGE.
 □ LOCATES PLATE CENTER.
